Cold Regions Research &
Engineering Laboratory

Special Report 84-5

Operation of the U.S. Combat Support Boat (USCSBMK I) on an ice-covered waterway

J. Stubstad, J. Rand and L. Jackson

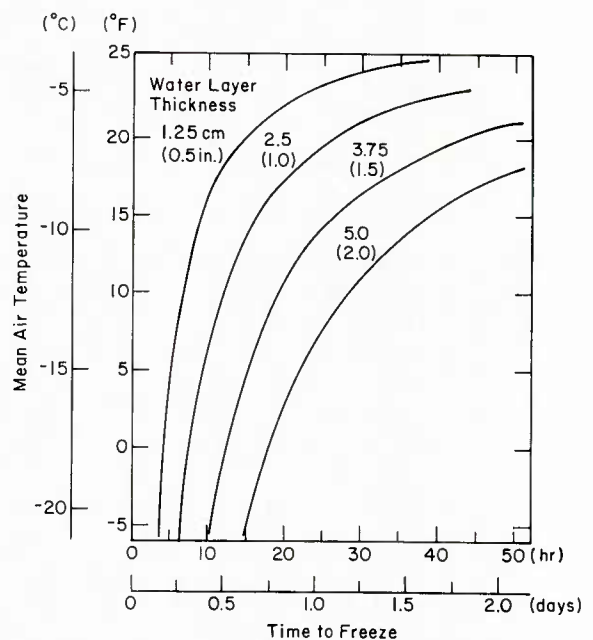
Figure 1. Freezing times for sea water layers on an ice sheet as a function of mean air temperature for 8 mile/hr (3.6 m/s) winds (After Adams et al. 1963).

layer depth on the amount of time required to freeze a layer of sea water on an ice sheet. Although we can anticipate that at any particular temperature the freezing rates for fresh water would be somewhat greater than those indicated in Figure 1, the same general curvilinear trends would prevail. Low air temperatures will produce rapid freezing while near-freezing temperatures result in exceedingly slow freezing.

Comparing the curves of Figure 1 with the data provided in Table 2, we can readily see that the climate of locations such as Barrow and Moosonee (James Bay) are ideally suited to ice bridge construction. Winter at these locations is sufficiently long and cold to provide rapid freezing rates. In contrast, Table 2 also indicates that such ideal ice bridge construction conditions are not commonly found in either the Federal Republic of Germany or the Republic of Korea. Thus, unless these areas were experiencing a sustained period of unseasonably cold weather, the construction of artificially thickened ice bridges to support military operations will, at best, be only marginally feasible.

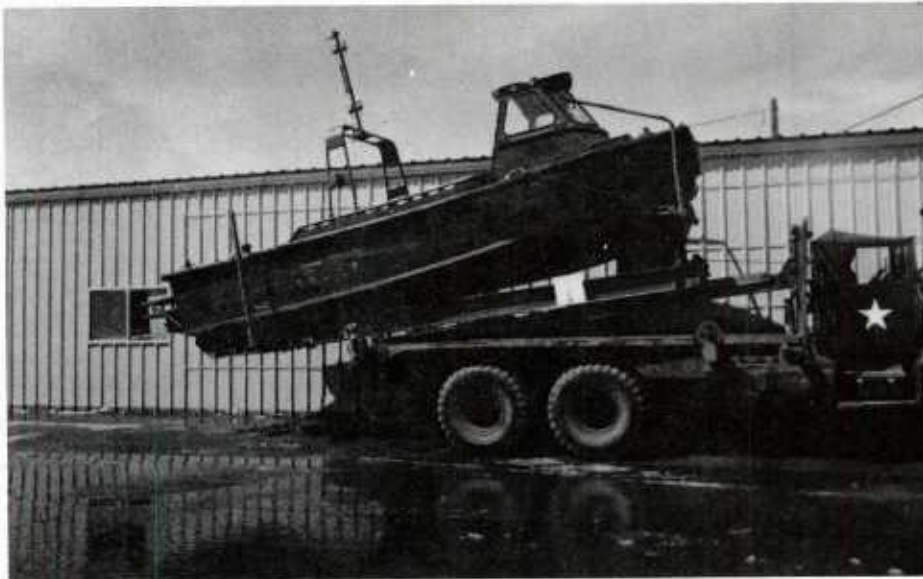
Figure 2. Combat Support Boat on transporter.

The Combat Support Boat (Fig. 2) is a 4-ton vessel with an aluminum hull that is powered by twin diesel engines. Each of these turbocharged diesel engines is used to drive hydrojet propulsion units that are mounted on the stern (Fig. 3). Each hydrojet is fitted with a scoop (water deflector) that

The Combat Support Boat is mounted on a modified M812 5-ton transporter for overland movement. An aluminum cradle adapts the boat to the transporter and acts as a ramp during launch (Fig. 2).

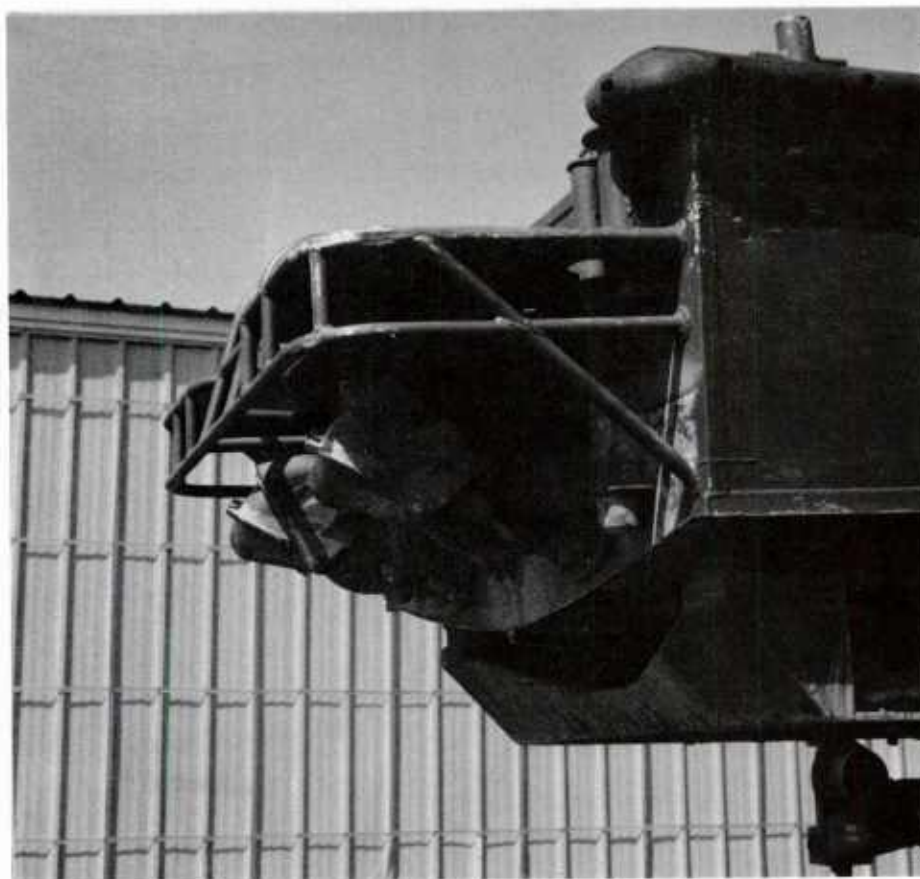
Figure 3. Hydrojet propulsion unit.

can be rotated over the jet outlet. When the scoop is pointed up it directs the flow of water toward the bow, generating a rearward thrust. The boat can be reversed by pointing the scoop down. This way, the boat's direction can be changed without reversing the direction of water flow through the hydrojet.

The hydrojet arrangement used on the boat also provides two methods for steering control. The steering wheel provides direct control by rotating the water jets to the left or right. An alternate method of steering is to point one scoop down (reverse) while the other is pointed up (forward). The opposing thrust forces produce a turning movement that can be used to maneuver the boat at low speeds. When these two methods are used together at low speed, the boat can make a complete turn within its own length.

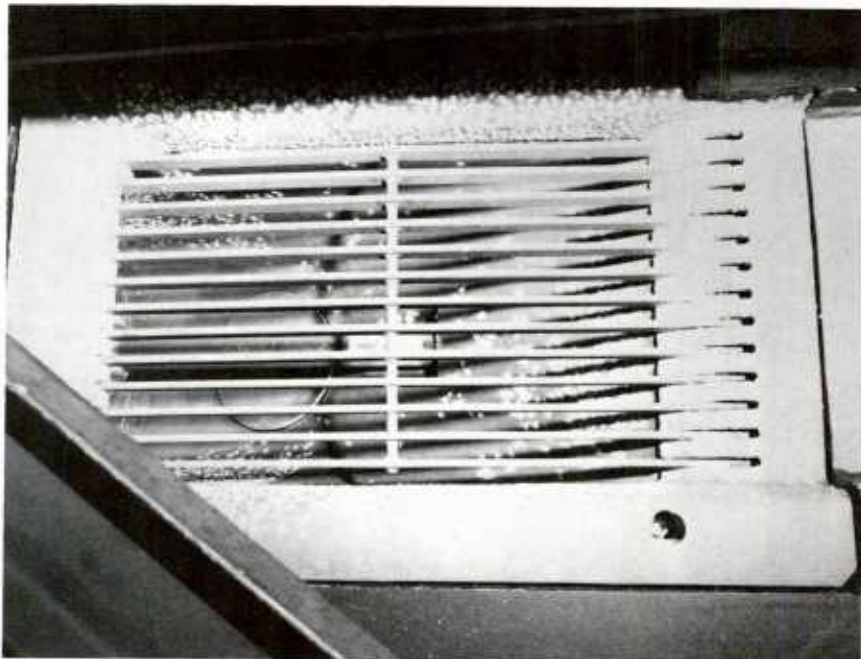
Figure 4. Hydrojet water intake with grille.

Water for the hydrojets is drawn through intakes located in the bottom of the hull, astern of the engine compartment. Each intake is covered by a grille (Fig. 4) to help keep debris from entering. An inspection port above the waterline over each intake is used to check for any debris jammed in the

grille or intake and, if necessary, to manually clear it. Normally, however, jams are cleared by back-flushing the hydrojets. To do this, a transmission that connects the engine to the hydrojet is put into reverse gear, thereby driving the hydrojet backwards. This reverses the flow of water through the hydrojet creating the desired flushing action.

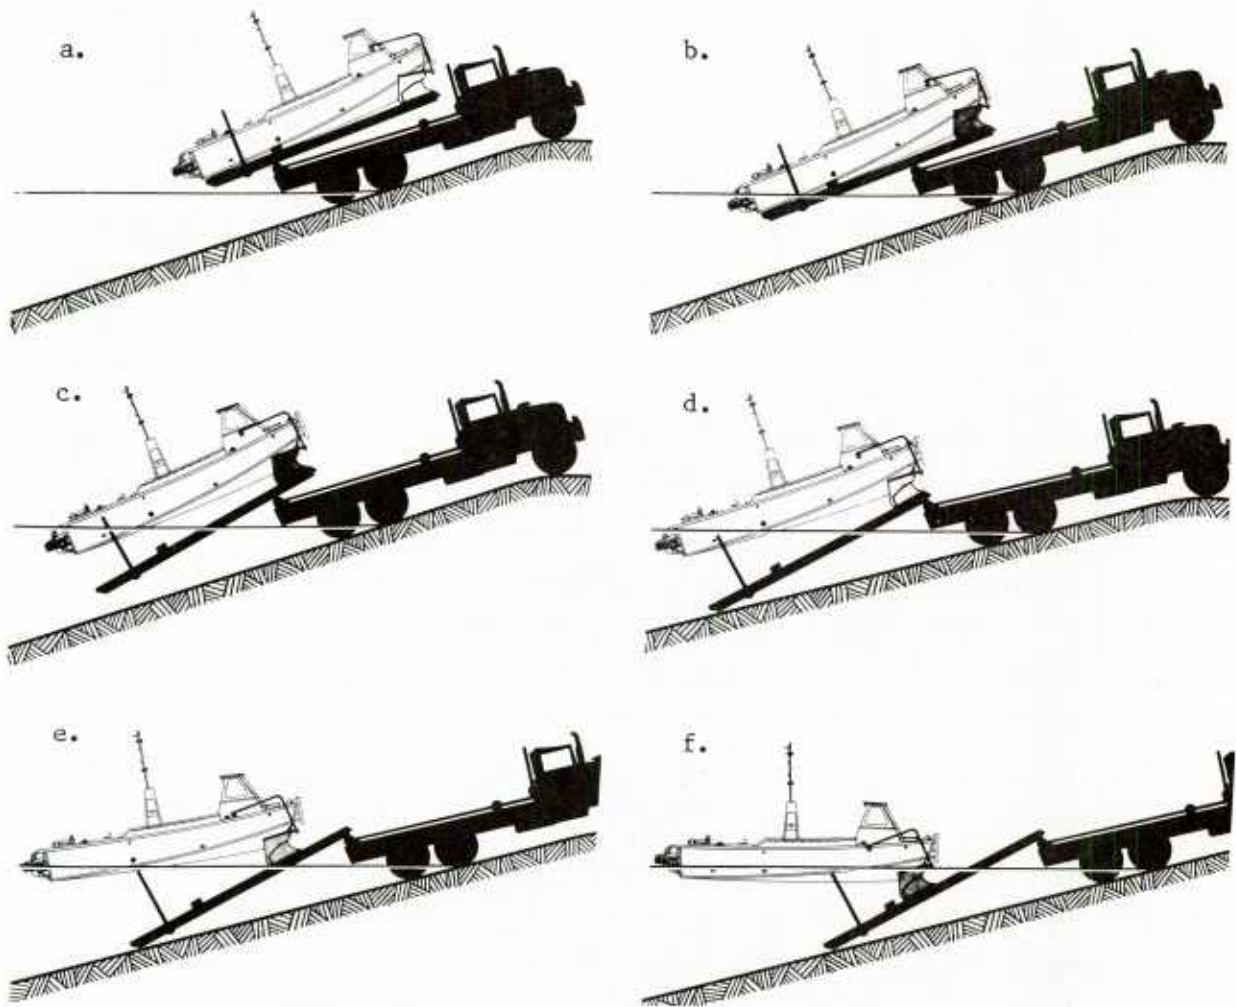
Figure 5. Normal launch sequence for the Combat Support Boat.

Launching the Combat Support Boat, when there is direct drive-in access at the river waterline, is a relatively simple procedure. The transporter is first backed into the water until the rear clearance lights of the transporter are approximately 6 in. above the waterline. The A-frame boom on the transporter is then raised slightly (Fig. 5a), using the A-frame hydraulic cylinder. A hydraulically operated locking pin that keeps the boat cradle on the A-frame is then disengaged and the boat and cradle assembly are allowed to roll off the rear of the transporter (Fig. 5b) under the control of a hydraulically operated winch.

As the stern of the boat enters the water (Fig. 5c), the flotation force that results separates the rear of the boat from the cradle. This separation takes place because the shoe that holds the bow of the boat can pivot with respect to the cradle dolly. Once the stern of the boat separates from the cradle, the rear of the cradle sinks to the bottom of the river keeping it from further rearward motion (Fig. 5d). Continued unreeling of the winch cable then allows the dolly to roll down the cradle (Fig. 5e and f), thereby lowering the bow of the boat into the river. At this point the engines are started, the safety cables that hold the bow of the boat to the dolly are removed and the boat is backed out of the shoe and away from the transporter and cradle, thereby completing the launch.

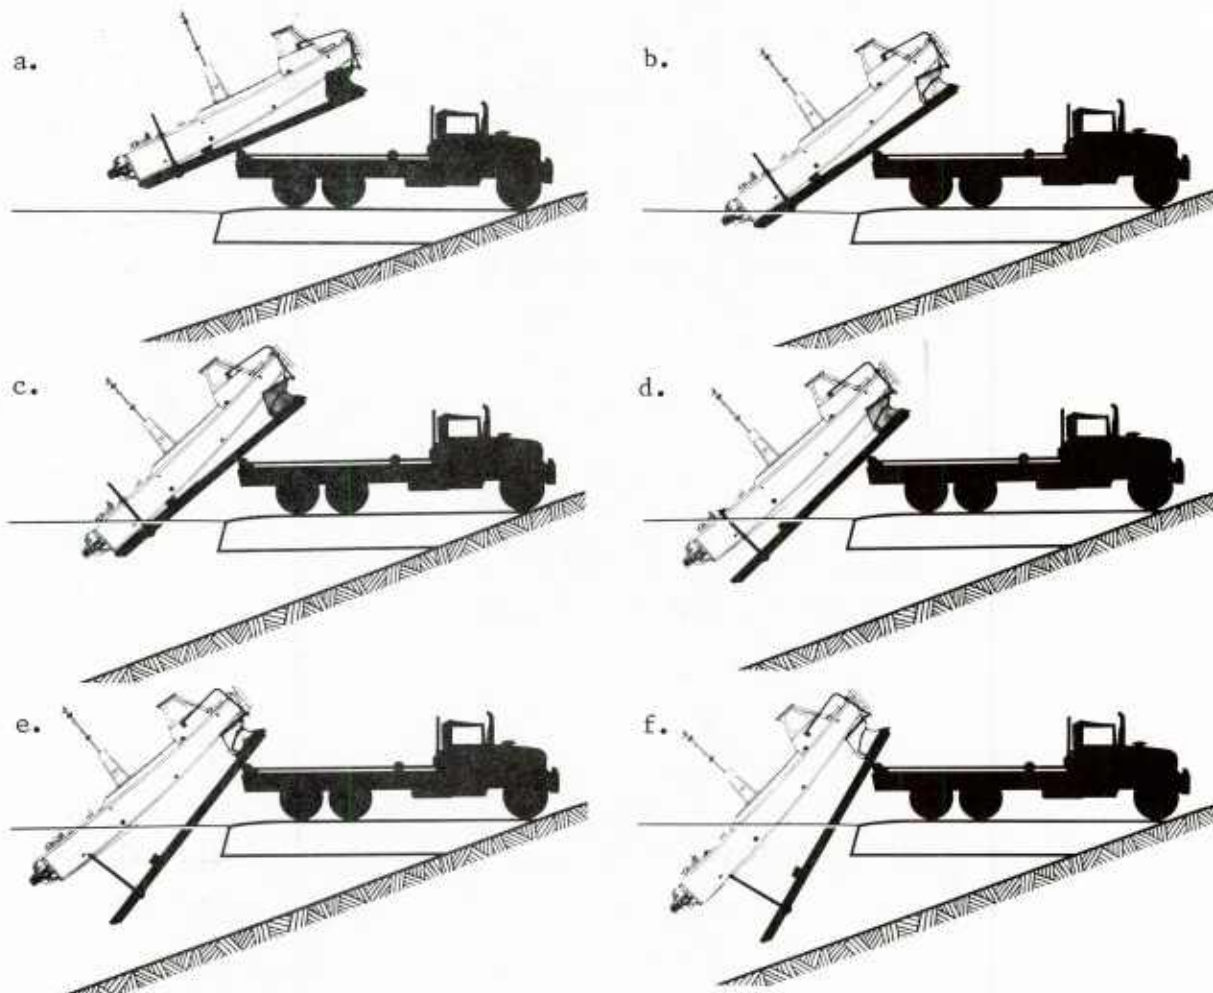
Figure 6. The Combat Support Boat can swamp when it is launched from a steep bank or ice shelf using the normal procedure.

At steeper launch angles, however, a portion of the rear deck as well as the watertight portion of the hull enters the water (Fig. 6). When this happens at least a portion of the stern hatch covers (Fig. 6d and 7) become submerged. Since these hatch covers are not watertight, water flows into the stern compartment. While this flooding does not physically harm the hydrojet and steering gear located in this compartment it does substantially reduce the flotation force generated. The net reduction in flotation force is, of course, directly proportional to the volume of water that enters the compartment.

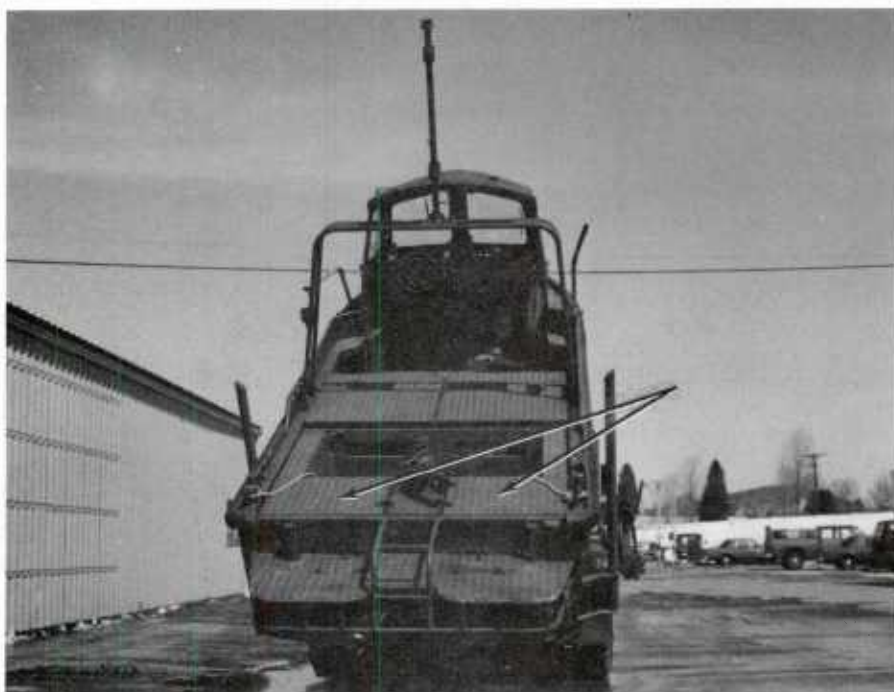
Figure 7. Location of stern hatch covers.

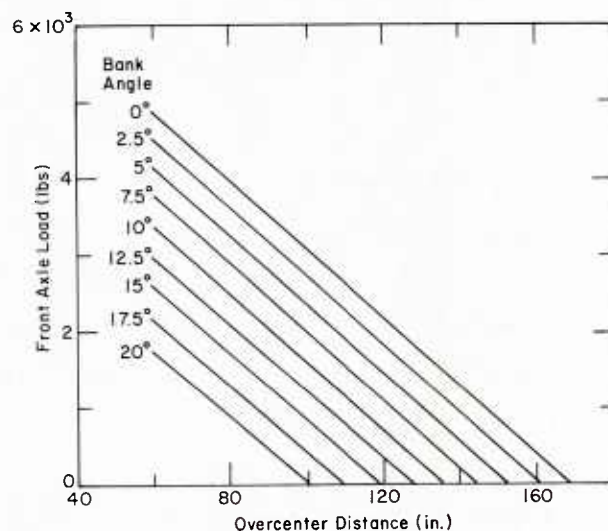
Figure 9. Variation in front axle load for various overcenter distances and bank angles.

Equations 4 and 5 allow the loads on the front and rear axles (note that the load on the rear axle is assumed to equal one-half the value of F_R) to be calculated as a function of the overcenter distance for any given bank angle. Figures 9 and 10 illustrate the variation in front and rear axle loads for selected bank angles. The combinations of bank angle and the overcenter distance that result in a "zero" front axle load represent the marginal stability conditions since with these combinations the transporter will be on the verge of overturning.

We may conclude from this analysis that, for any given bank angle, the marginal stability condition is best avoided by minimizing the overcenter distance (i.e., distance "x" on Fig. 8) during the entire launch process. Unfortunately, this can only be done by moving the transporter as close to the outer edge of the ice shelf as possible. Since an ice shelf is a cantilever structure, moving the transporter to the outer (free) edge of the shelf increases the induced bending moments and thus increases the level of stress in the ice, especially at the junction between the ice shelf and the river bank. In turn, this increases the possibility of fracturing of the ice shelf or

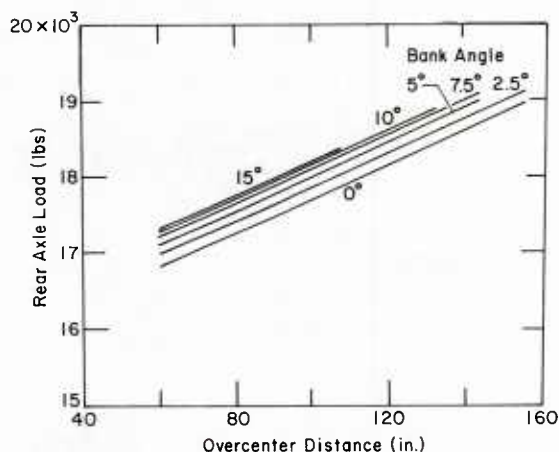
Figure 10. Variation in rear axle load for various overcenter distances and bank angles.

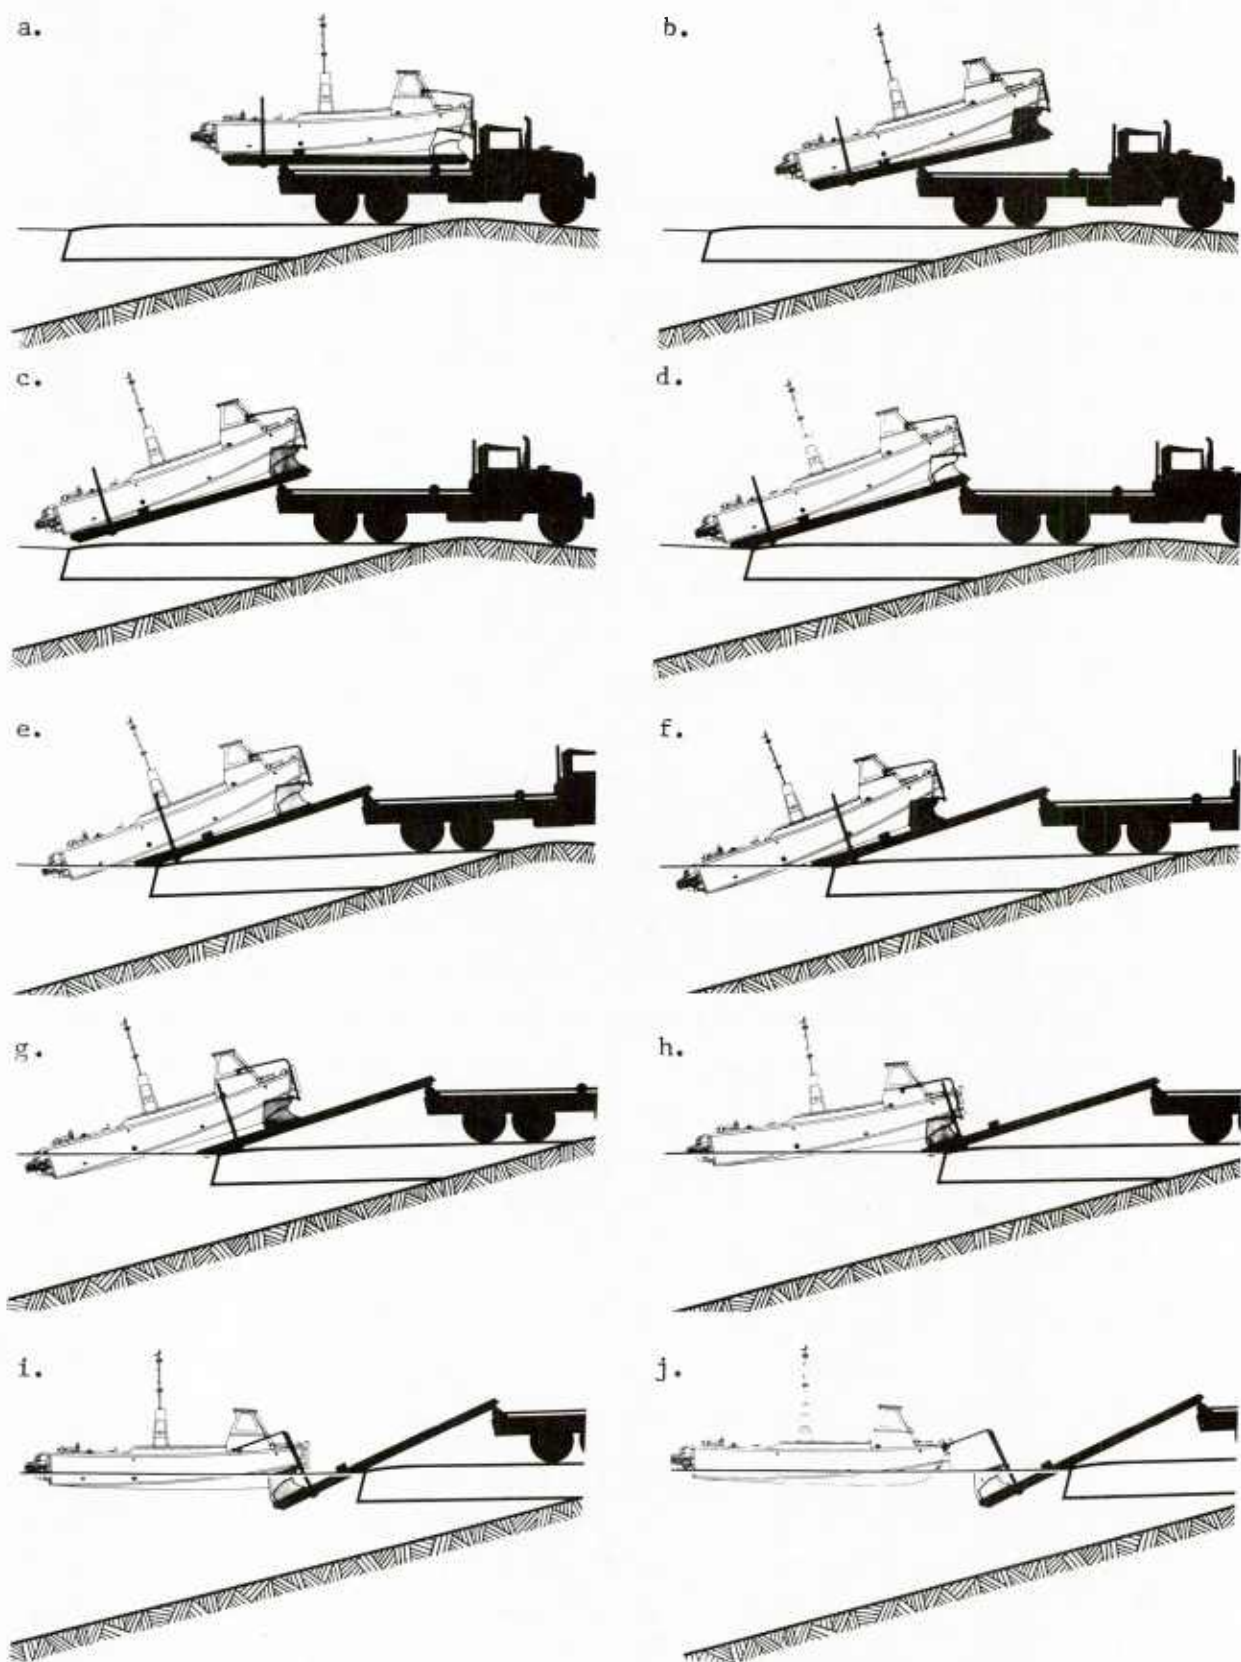
Figure 11. Procedure developed by CRREL for launching the Combat Support Boat from an ice shelf.

The ice shelf launch procedure ultimately developed at CRREL (Fig. 11) completely satisfies the first two criteria and partially satisfies the third. The procedure begins by locating the transporter (Fig. 11a) so that the centerline of the rearmost axle is slightly less than 15 ft from the edge of the ice sheet. The A-frame boom is then raised slightly and the winch cable is slowly released, allowing the boat and cradle to roll off the transporter (Fig. 11b). Because of the distance of the transporter from the edge of the ice sheet, the lower rear edge of the cradle will not come to rest on

the upper surface of the ice. Instead (Fig. 11c and d), it will project over the edge of the ice shelf.

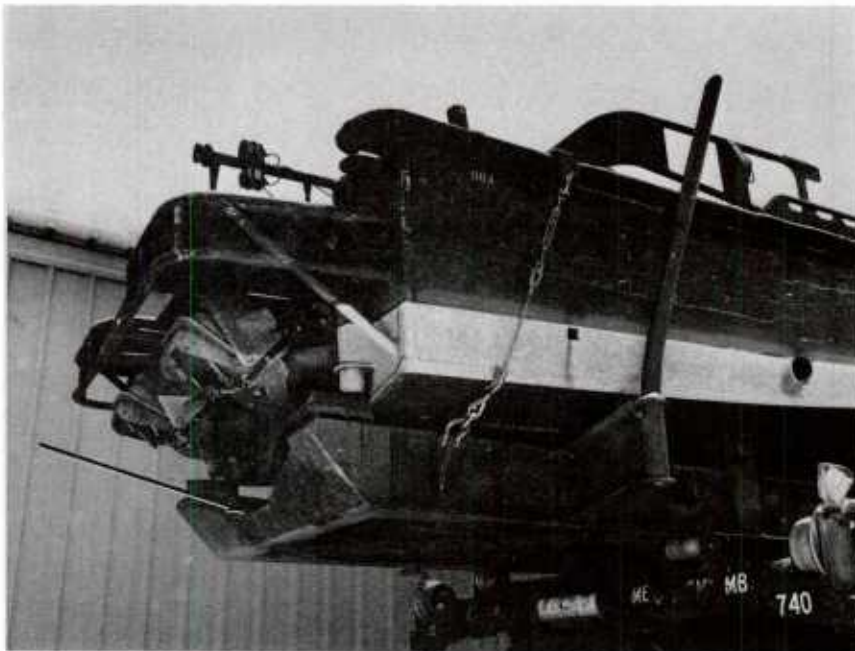
Figure A1. Aft transverse member of Combat Support Boat's cradle.

Figure A1 illustrates the transverse member that connects the aft ends of the main cradle beams. This transverse member is a welded aluminum box section that provides transverse and torsional rigidity for the cradle.

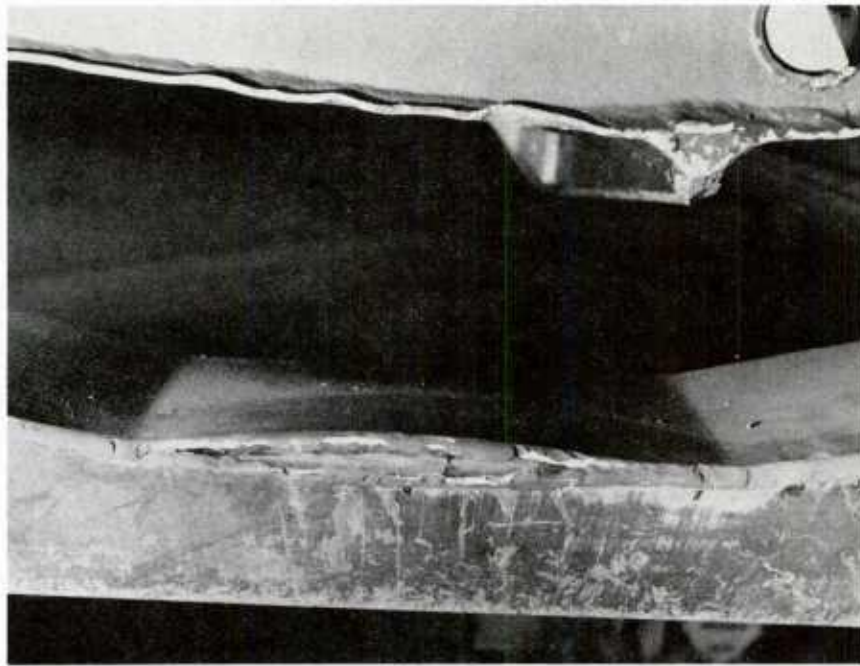
Figure A2. Crack produced by freezing of water trapped in aft transverse member.

Figure A2 illustrates the crack that was created in this member by freezing of water trapped inside it. We assume that water entered the member during launch and recovery because the weld joints did not provide a com-

pletely watertight seal. Filled with water and exposed to overnight sub-freezing air temperatures, the member was unable to vent or otherwise relieve the pressures generated as the water froze and expanded, and therefore it cracked.
